Inspection Report

Sample House

Property Address:
310 Inspection Road
Hometown FL

HousePro Inspection Services

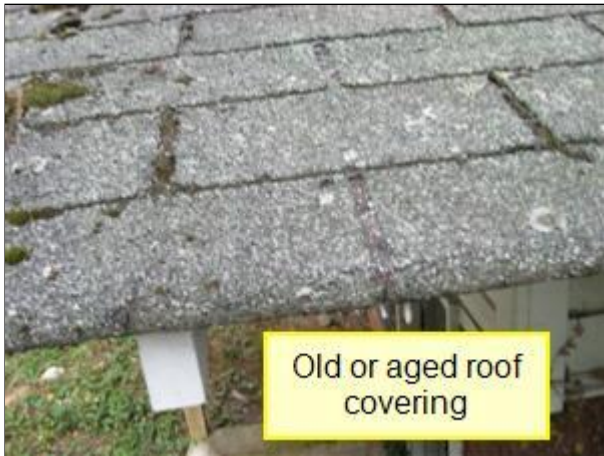
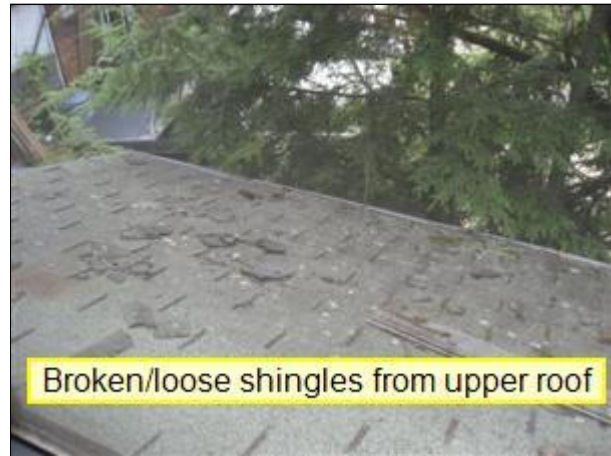
1.0 (1) The roof covering is old, and the life of covering has expired. The covering does need to be replaced. While it could last a year or so, some areas may need patching with tar as leaks develop. Some shingles are missing on main roof and daylight can be seen from attic. Immediate repairs are needed here.

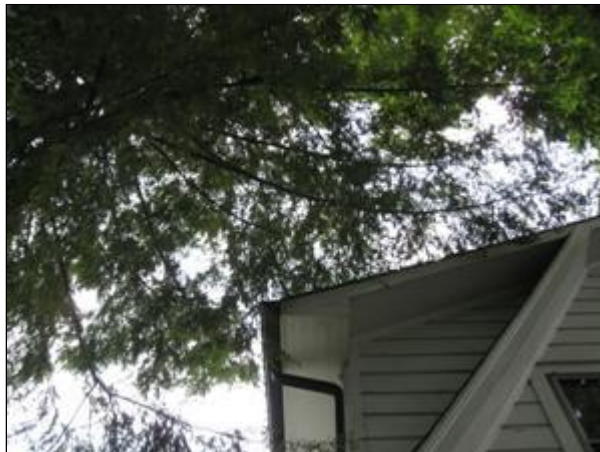
1.0 Picture 3

(2) The tree limbs that are in contact with roof or hanging near roof should be trimmed.

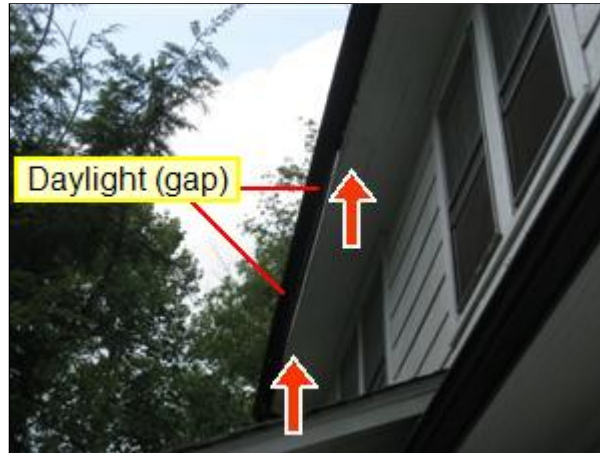
1.3 Picture 1

1.3 (1) The gutter is loose or daylight between gutters and fascia at the rear. Loose or leaking gutters can cause deterioration of fascia, soffit or roof edge. It can also cause gutters to pull loose and lead to possible water intrusion. A qualified contractor should inspect and repair as needed.

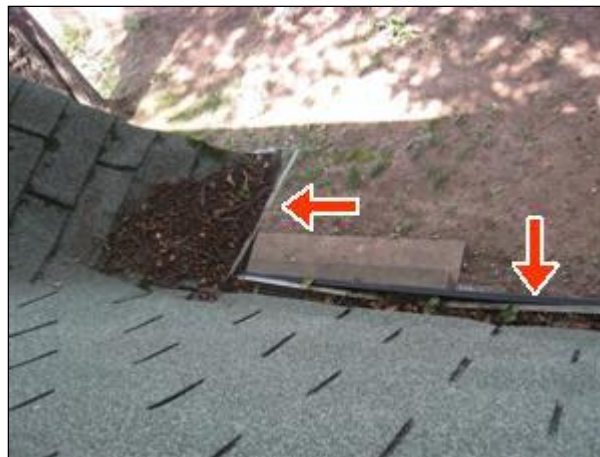
1.3 Picture 2

1.3 (2) The gutter screens collapsed inside gutter at the front of home. A qualified person should repair or replace as needed. The gutter needs cleaning of debris at the front and as needed elsewhere. Gutters that drain poorly or clogged can lead to many costly problems such as deterioration of fascia, soffit or roof edge. It can also cause gutters to pull loose and lead to possible water intrusion. A qualified person should repair or replace as needed.

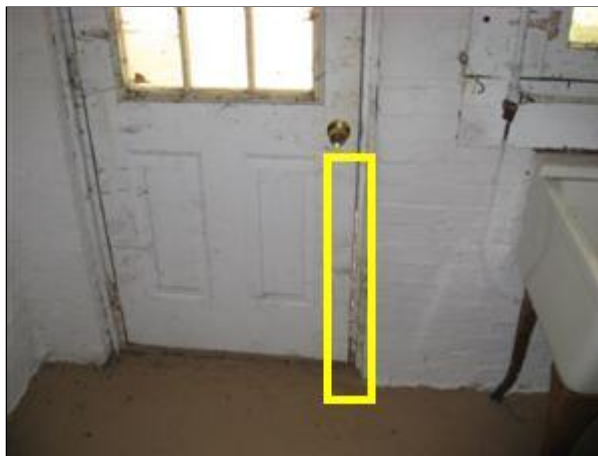
2.1 Picture 1 Basement entry

**2.1** The side entry door to basement reveals daylight when latched at areas missing weather-stripping. This is a small repair. A qualified person should repair or replace as needed.

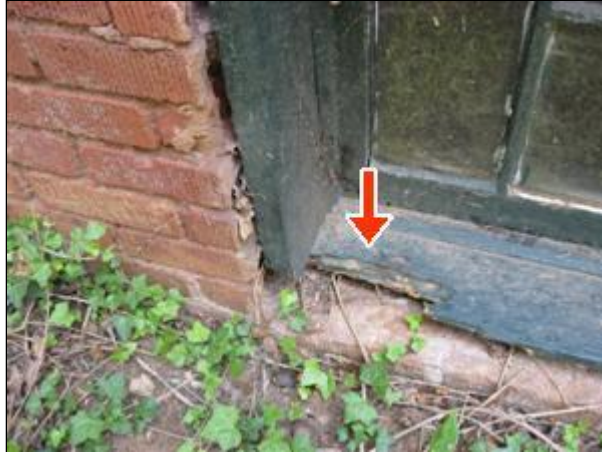
2.2 Picture 1 Basement window (s)

2.2 The sill plate is deteriorated at right side (facing front). This is a small repair. A qualified person should repair or replace as needed.

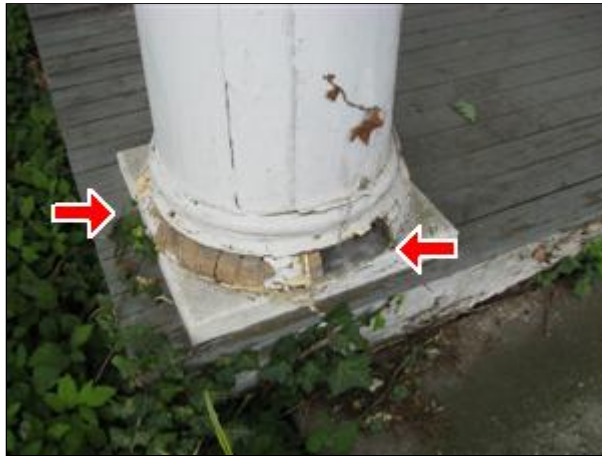
2.3 Picture 1 Front Porch

2.3 (1) The support column(s) on covered porch at the left side (facing front) are split or cracked in areas and are deteriorated in areas. A repair or replacement is needed. A qualified contractor should perform the work.

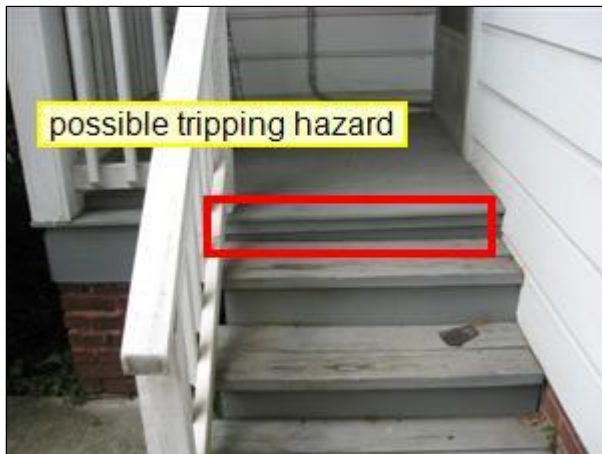
2.3 Picture 2 Rear Porch

2.3 (2) The steps on the porch at the rear of home are not uniform in "riser height" and are a tripping hazard. A fall or injury could occur if not corrected. I recommend repair as needed.

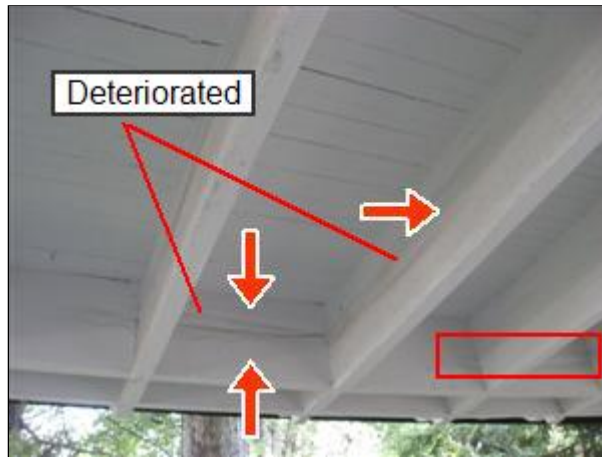
2.3 Picture 3

🏠 (3) Some of the rafters of covered porch shows weakening by previous damage from leaks or other. Appears to remain strong to function. FYI

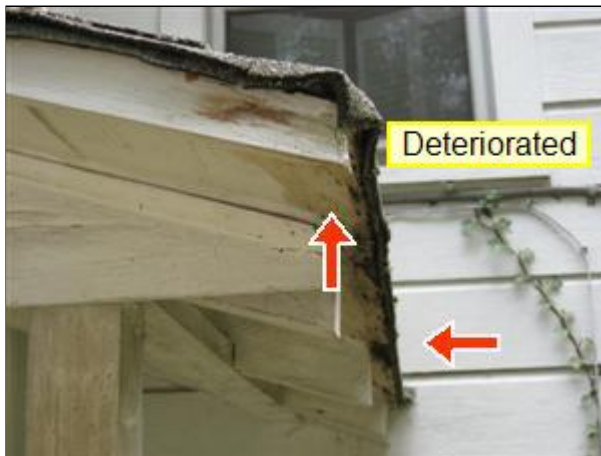
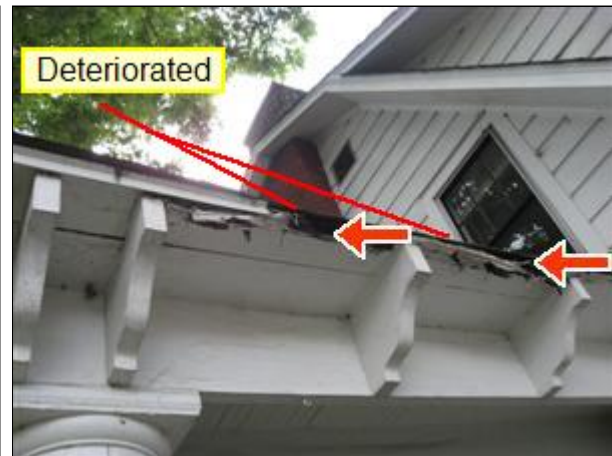
🏠 2.5 (1) The eave boards at eave on the gables and various roof edges are deteriorated. Repairs are needed. A qualified contractor should inspect and repair as needed.

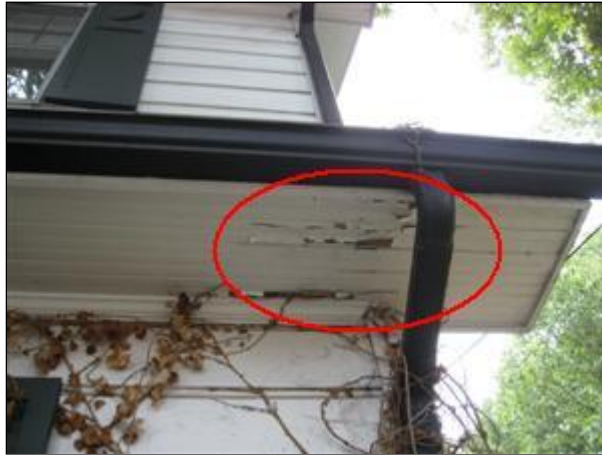
2.5 Picture 3 Front (right of main entry)

🏠 (2) The soffit panel at eave on the front (right of main entry) are weathered and peeling paint. Further deterioration may occur if not repaired. A qualified person should repair or as needed. I am unable to determine if leak exists here or was a result of clogged gutters.

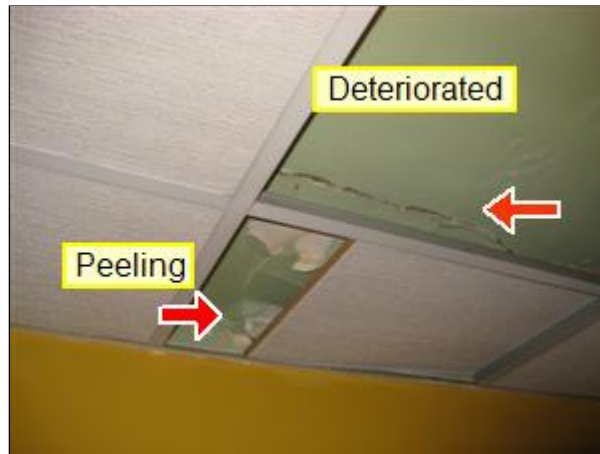
3.0 Picture 1

**3.0** (1) Plaster ceiling is in need of repair in bathroom. Currently it is covered by drop panels.

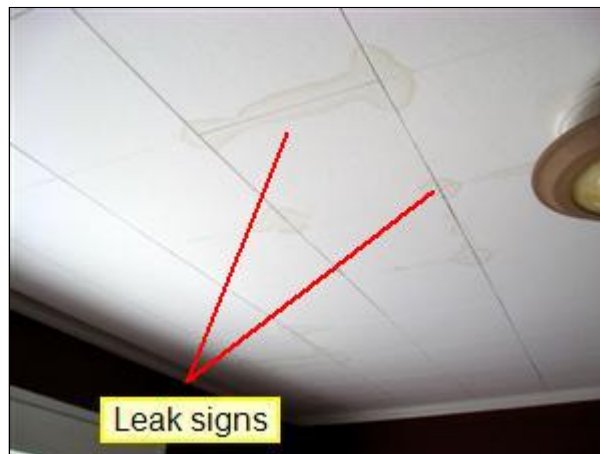
3.0 Picture 2

(2) The Ceiling Tile on the ceiling reveals a water stain indicating a leak did or still exists at the Bedroom. Due to recent dry weather, I am unable to determine if the leak still exists. A qualified contractor should inspect and repair as needed.

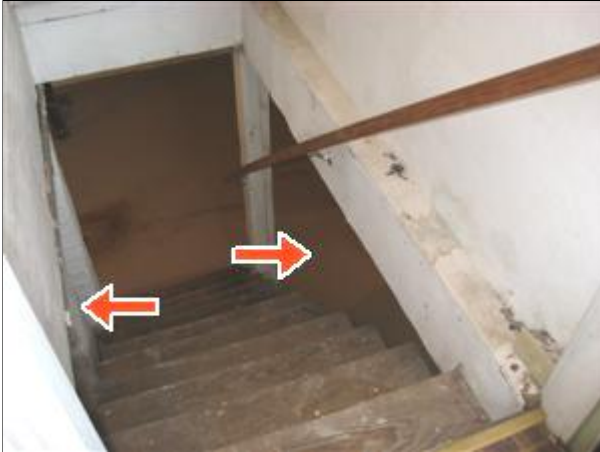
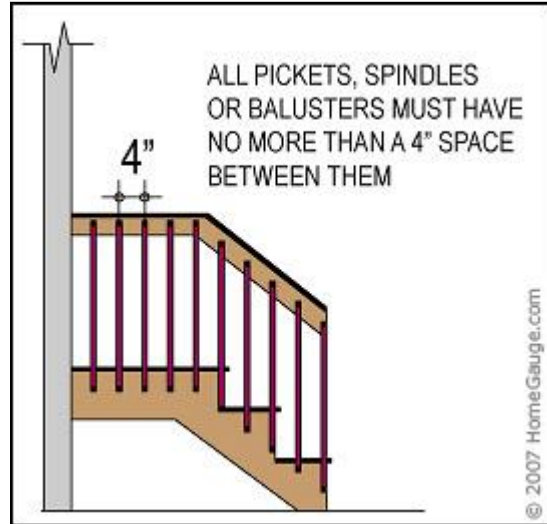
3.3 The hand/guard rail for the stairs to basement are missing balusters (on both sides). A fall or injury could occur if not corrected. A qualified contractor should repair or replace as needed.

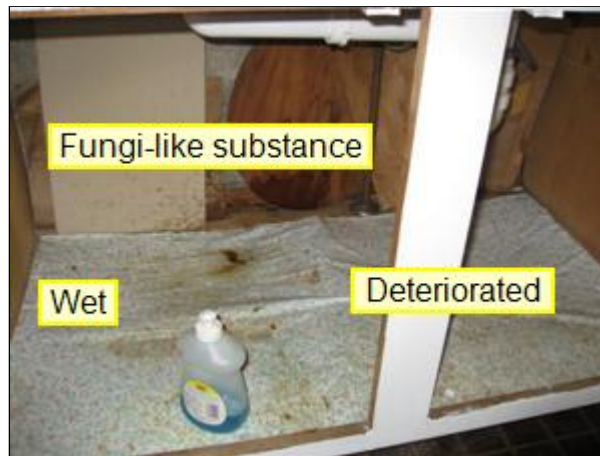
3.4 Picture 1 under kitchen sink

3.4 Sink base is damaged under sink at bottom shelf likely from leaking faucet. Recommend repair or replace sink base cabinetry as necessary.

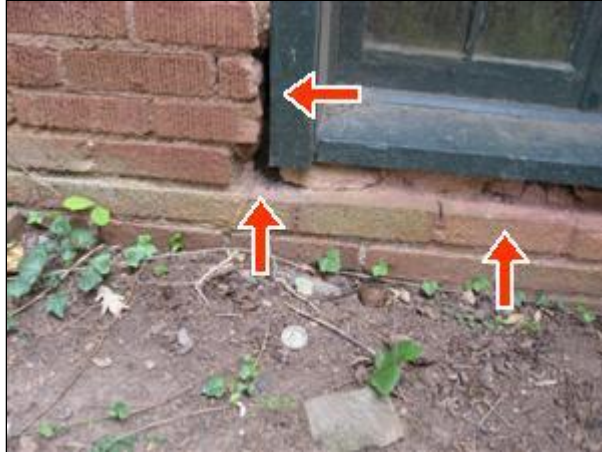
4.0 Picture 1

4.0 (1) Brick Foundation wall at the basement entry has missing mortar around windows . Repairs are needed. A skilled masonry contractor should perform the repairs.

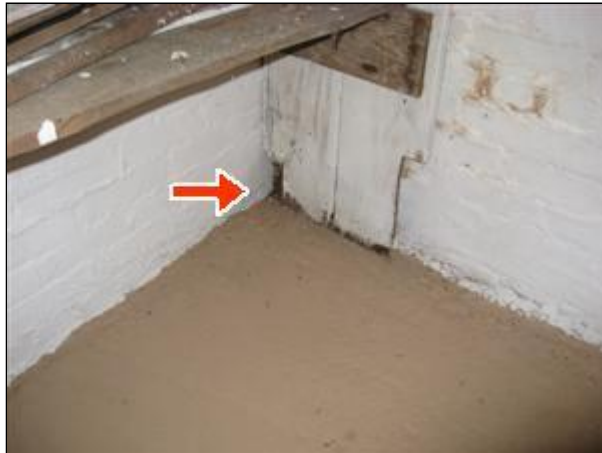
4.0 Picture 2 basement wall

4.0 (2) The brick foundation has been coated with a water proof sealer except behind shelving. If water intrusion occurs here, then shelving may need removing in order to coat area properly.

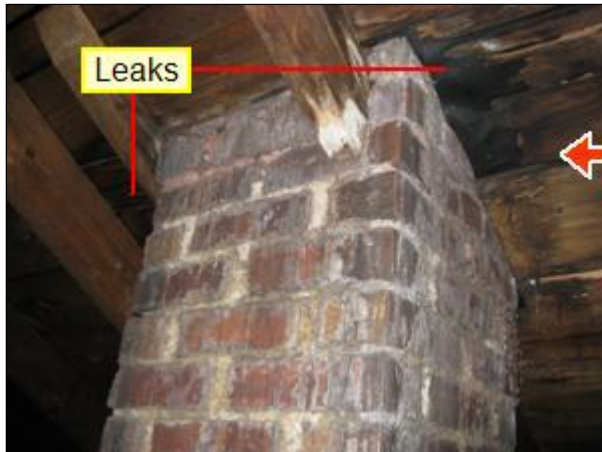
4.5 Picture 1

4.5 The common board roofing indicates roof leaks or has leaked around the chimneys. Leaking roofs should be repaired to prevent damage. I recommend a qualified contractor perform the work. (See Roof Coverings comments)

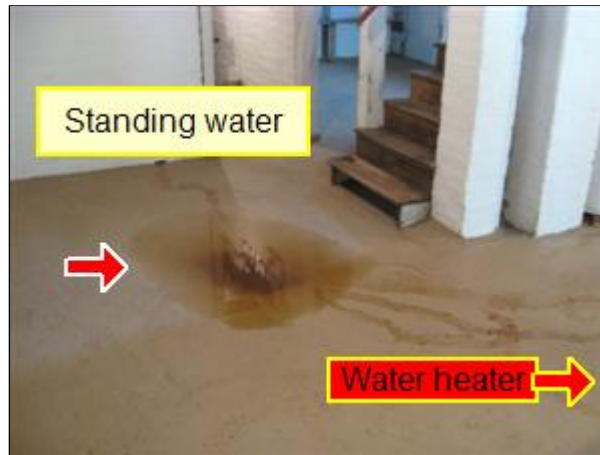
5.0 Picture 1

🏠 5.0 (1) Upon arriving water was on and spilling onto floor of basement from nearby faucet and water heater. The hvac person who was their at the time of inspection claimed that he turned the water on at the street. I turned off the valve at faucet and water heater.
FYI

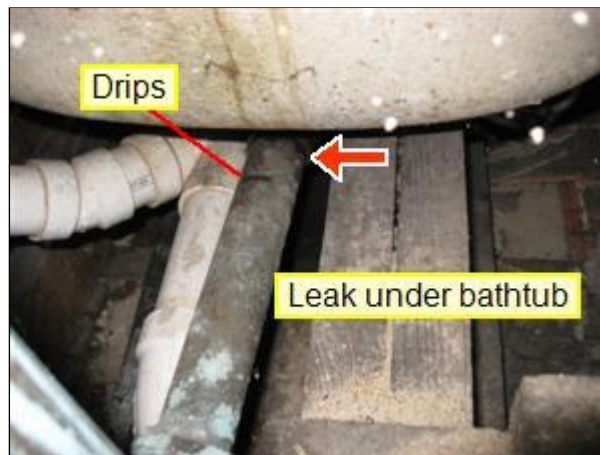
5.0 Picture 2 Upstairs bath

🏠 (2) The stop-valve does not work properly at the Hall Bath sink. Repairs are needed. The tub drain drains slowly at main bath. There is a leak under bathtub that can be seen from removing access panel on wall. Repairs are needed. A qualified licensed plumber should repair or correct as needed.

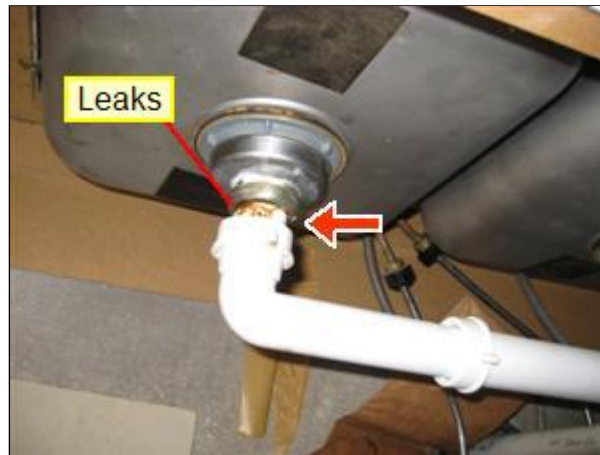
5.0 Picture 3

(3) The basket strainer is leaking at left side and at right side at the Kitchen sink. Repairs are needed. A qualified licensed plumber should repair or correct as needed.

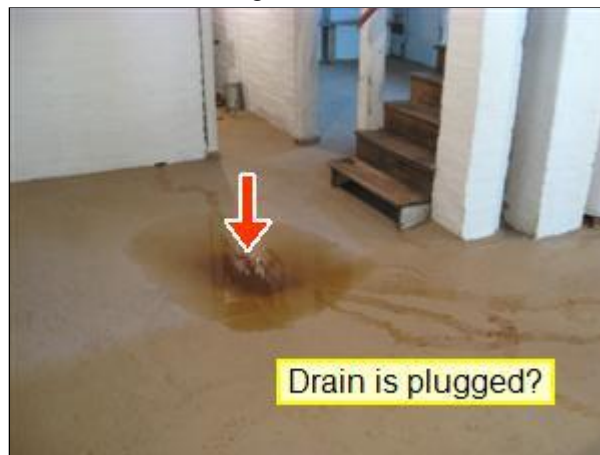
5.0 Picture 4 basement floor drain

(4) The floor drain has a plug as if to keep something from coming in? After the inspection, the owner of the adjacent property volunteered information that the city sewer occasionally will back up and come into basement. This may be the reason for the plug? I am unable to determine if plug will prevent this from occurring. FYI

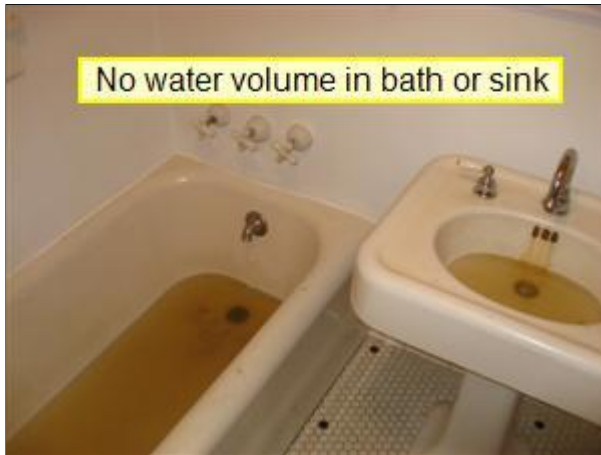
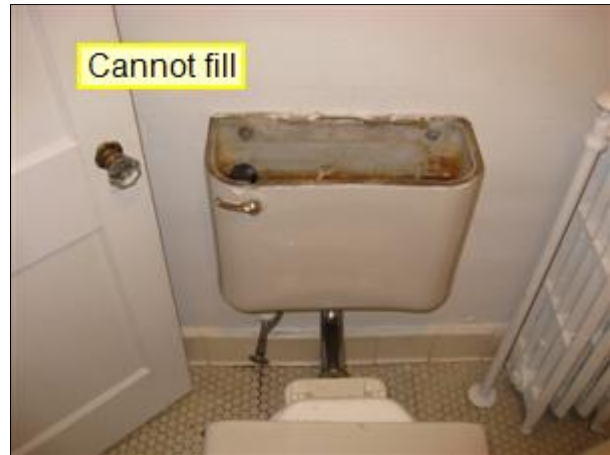
(2) The water pressure over-all is poor and would not pass "functional flow." A possible reason for weak volume or pressure could be old galvanized piping that is corroded inside. NOTE: NO SHOWER FOR BATH

Toilet will not fill with water likely due to clogged piping. I could not inspect the toilet fixture for leaks.

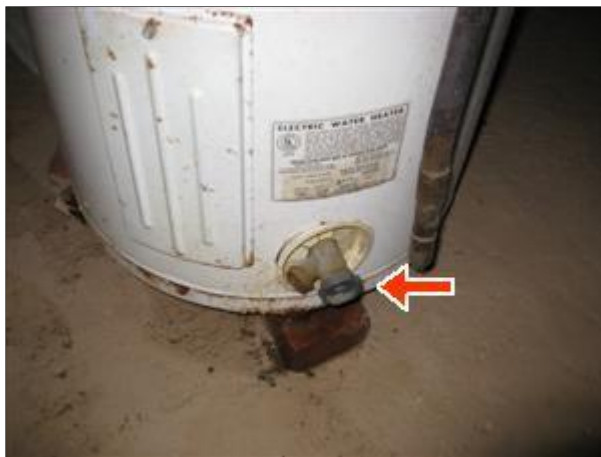
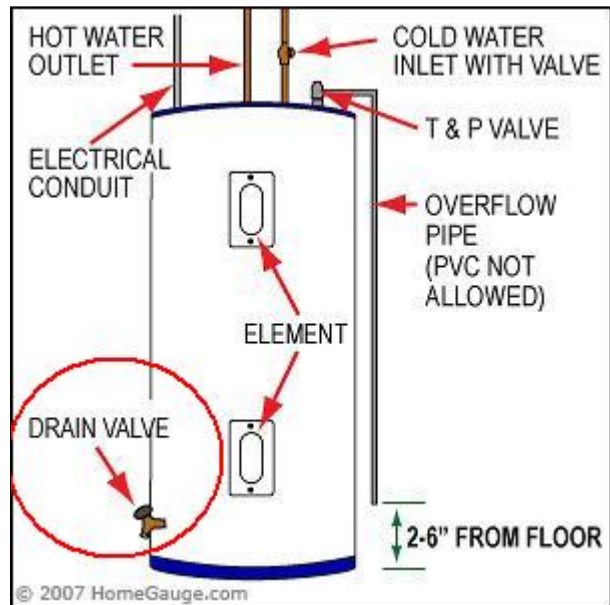
5.2 Water heater was empty and drain open at bottom when I arrived. I closed drain but at the end of inspection, drips were still occurring. Repairs may be needed.

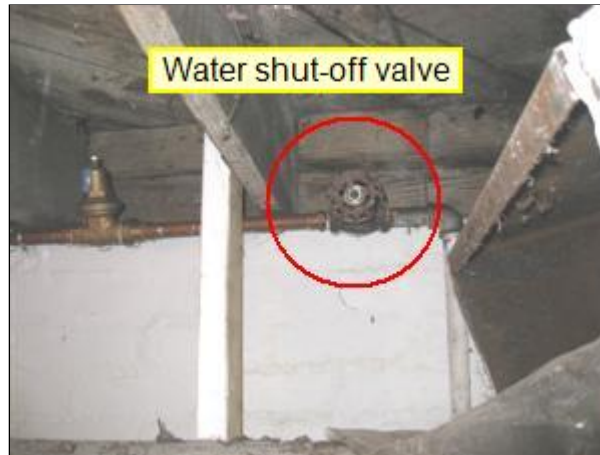
5.3 Picture 1

5.3 The main shut off is the red knob located in the basement on the front wall. This is for your information.

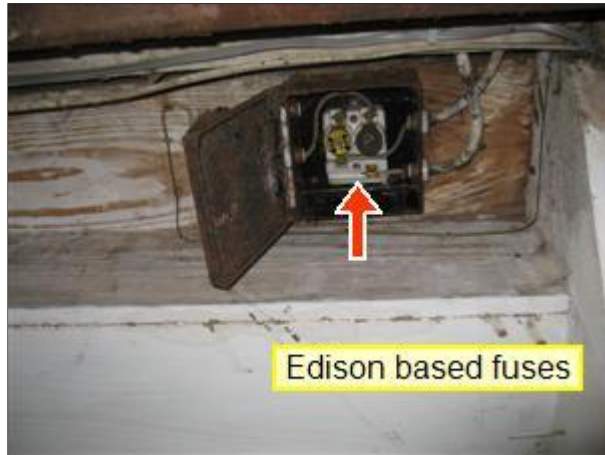
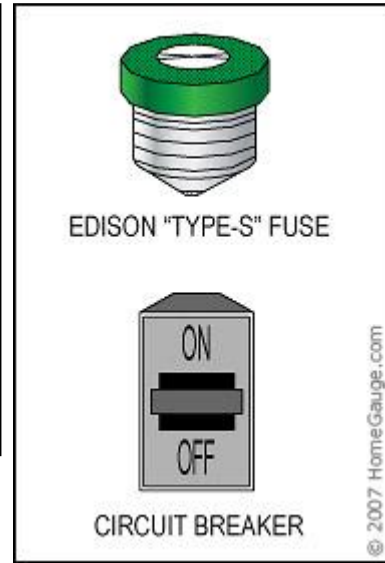
6.2 Problem(s) discovered with Branch Circuits such as doubled wiring at fuse(s), doubled wiring at circuit(s), and edison base fuse(s) under stairs, and any other problems that an electrician may discover while performing repairs need correcting. I recommend a licensed electrician inspect further and correct as needed.

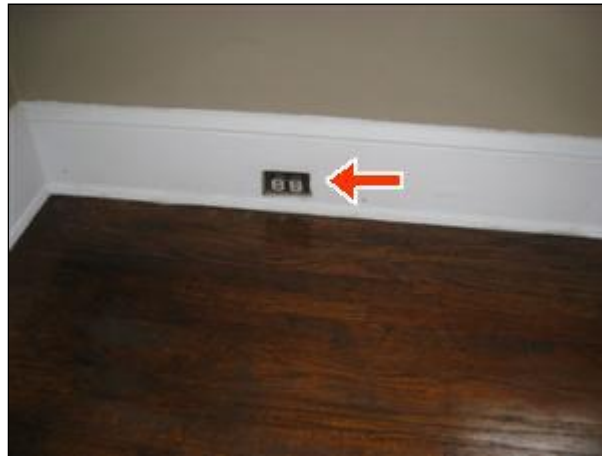
6.3 Picture 1 various rooms

6.3 (1) "Two-prong" outlets are missing cover-plates in the dining room and in the living room. This is a safety issue that needs to be corrected. I recommend repair as needed.

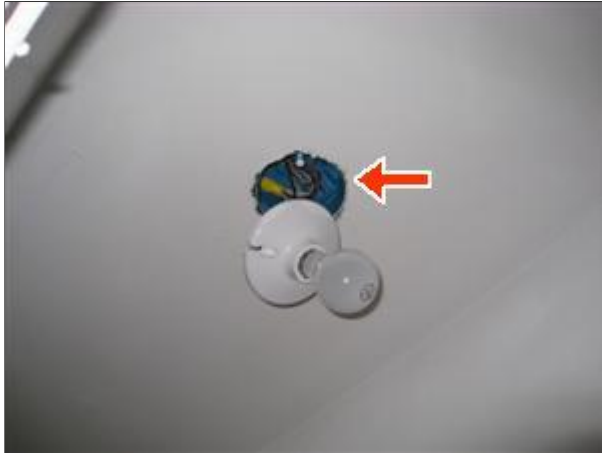
6.3 Picture 2

🏠 (2) Loose light fixture needs securing in closet. Loose or unfinished wiring in attic should be corrected to remain safe (Picture 2)
.One splice box needs a cover-plate in the basement. I recommend repair as needed (Picture 4) .

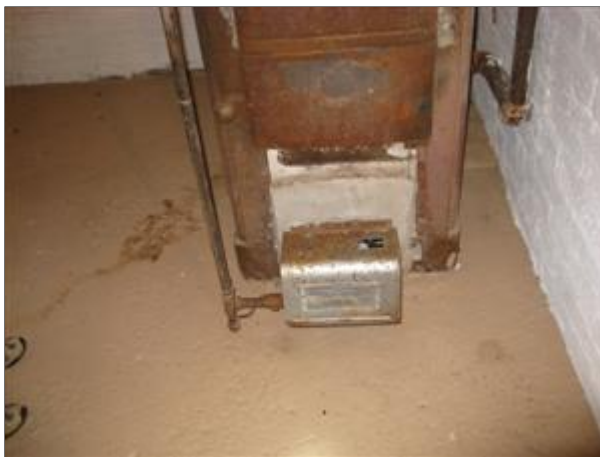
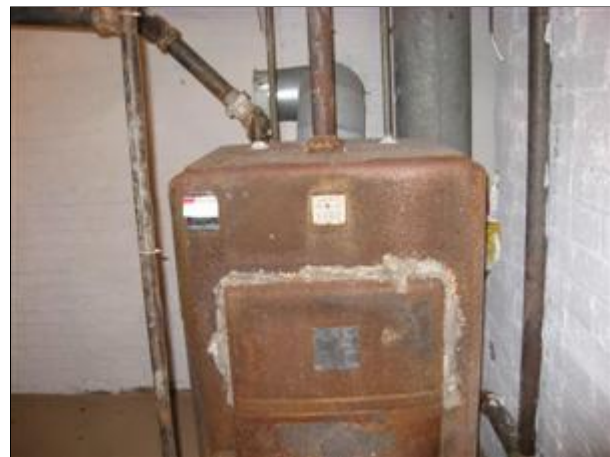
**7.0** The gas-fired boiler did not function or is non-operational. A repair or replacement is needed. I recommend further inspection by a licensed HVAC contractor.

**7.3** Due to the concern for water volume or pressure and because of the old piping that was turned off for an extended period of time, and the fact that the boiler is non-operational, I am concerned of whether or not the radiators will function properly when boiler is repaired. A clogged or failed radiator can be expensive to replace. I strongly recommend that an HVAC person inspect all the radiators

when boiler becomes operable. You should obtain a letter from the HVAC company as to the condition of radiators, piping and boiler before you close on home.

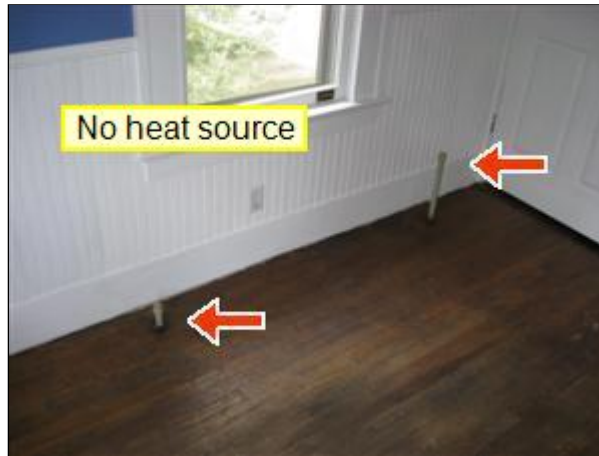
7.4 Picture 1 bedroom

7.4 There is no heat source for Bedroom on right (at top of stairs).

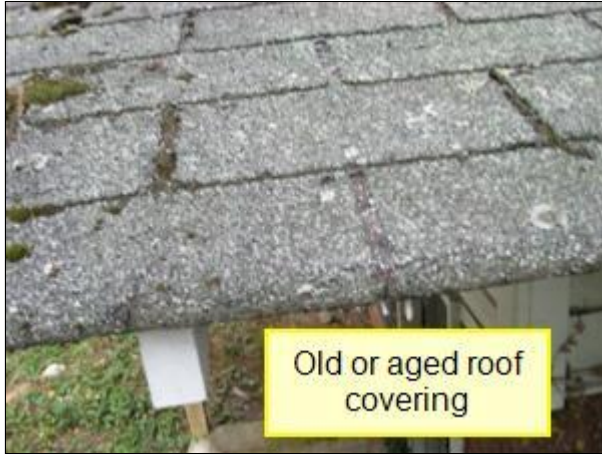
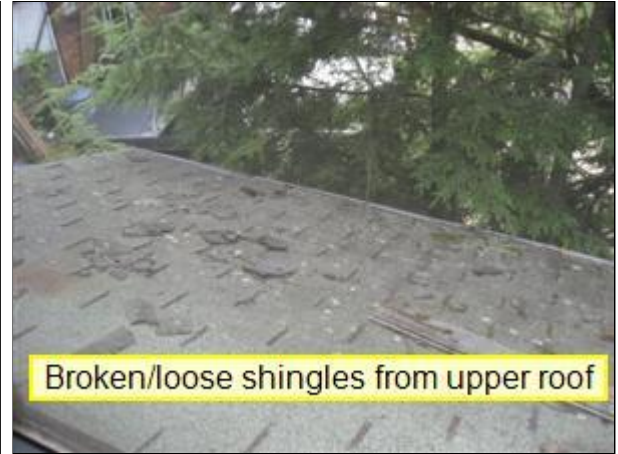
(1) The roof covering is old, and the life of covering has expired. The covering does need to be replaced. While it could last a year or so, some areas may need patching with tar as leaks develop. Some shingles are missing on main roof and daylight can be seen from attic. Immediate repairs are needed here.

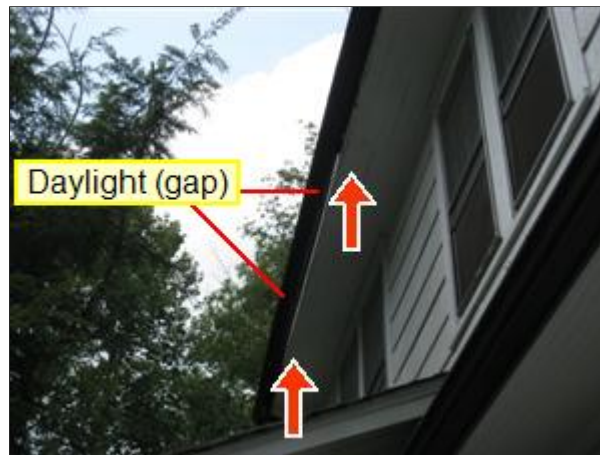
1.3 Picture 1

(1) The gutter is loose or daylight between gutters and fascia at the rear. Loose or leaking gutters can cause deterioration of fascia, soffit or roof edge. It can also cause gutters to pull loose and lead to possible water intrusion. A qualified contractor should inspect and repair as needed.

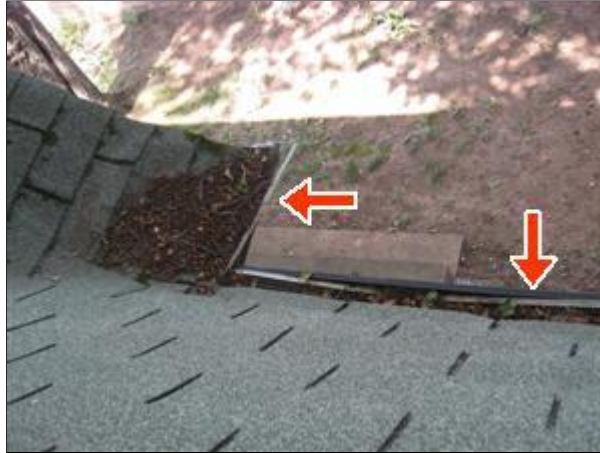
1.3 Picture 2

costly problems such as deterioration of fascia, soffit or roof edge. It can also cause gutters to pull loose and lead to possible water intrusion. A qualified person should repair or replace as needed.

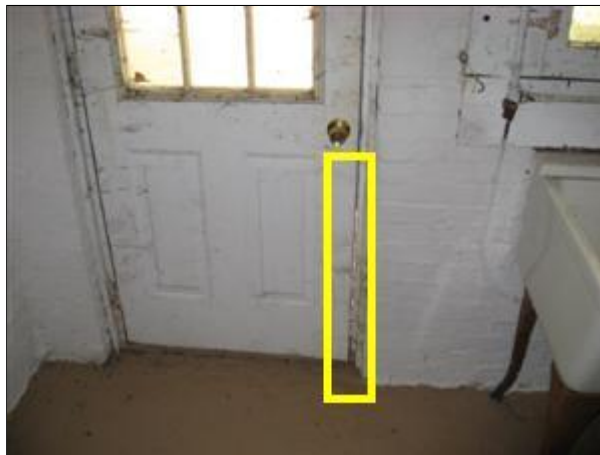
2.1 Picture 1 Basement entry

The side entry door to basement reveals daylight when latched at areas missing weather-stripping. This is a small repair. A qualified person should repair or replace as needed.

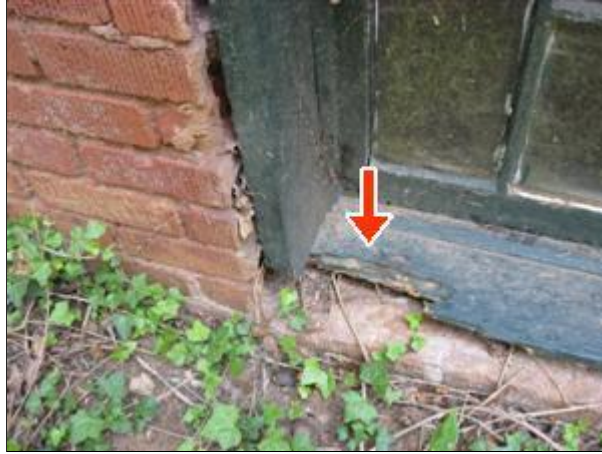
2.2 Picture 1 Basement window (s)

The sill plate is deteriorated at right side (facing front). This is a small repair. A qualified person should repair or replace as needed.

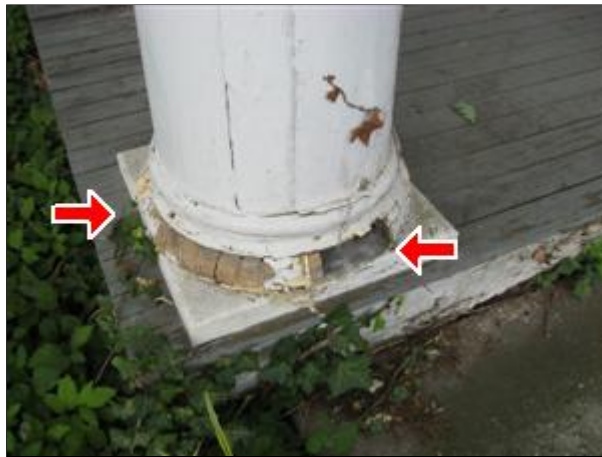
2.3 Picture 1 Front Porch

(1) The support column(s) on covered porch at the left side (facing front) are split or cracked in areas and are deteriorated in areas. A repair or replacement is needed. A qualified contractor should perform the work.

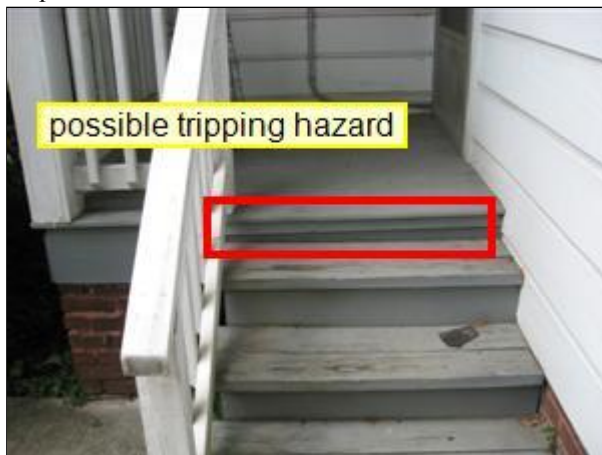
2.3 Picture 2 Rear Porch

(2) The steps on the porch at the rear of home are not uniform in "riser height" and are a tripping hazard. A fall or injury could occur if not corrected. I recommend repair as needed.

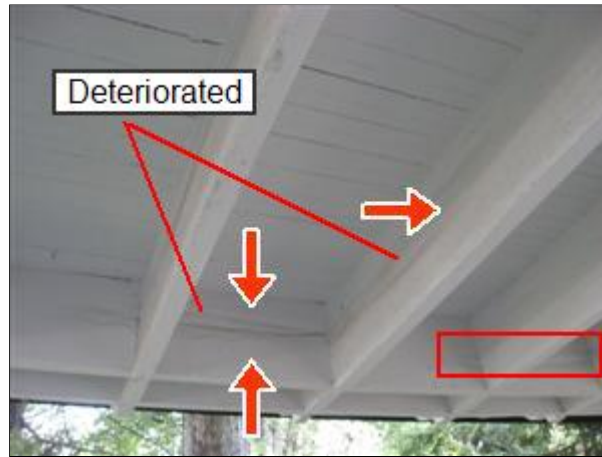
2.3 Picture 3

(3) Some of the rafters of covered porch shows weakening by previous damage from leaks or other. Appears to remain strong to function. FYI

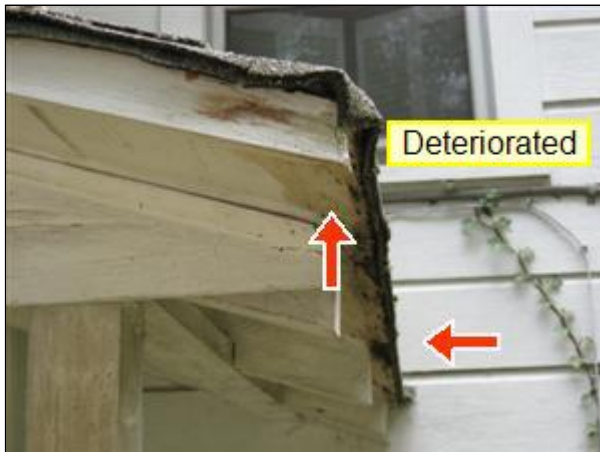
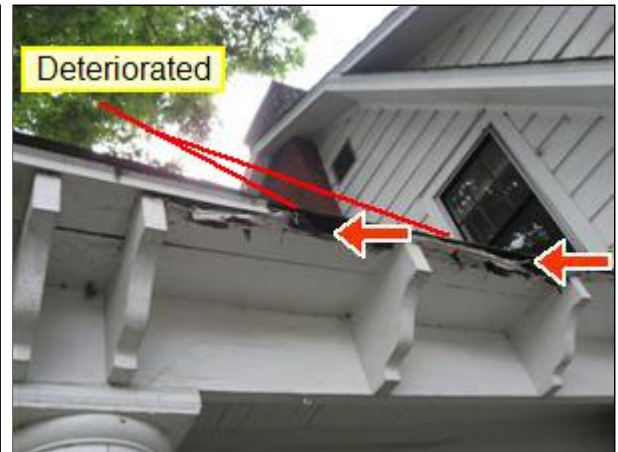
(1) The eave boards at eave on the gables and various roof edges are deteriorated. Repairs are needed. A qualified contractor should inspect and repair as needed.

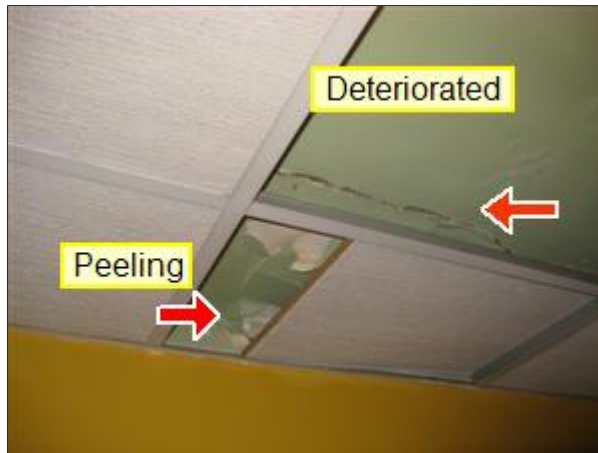
3.0 Picture 1

(1) Plaster ceiling is in need of repair in bathroom. Currently it is covered by drop panels.

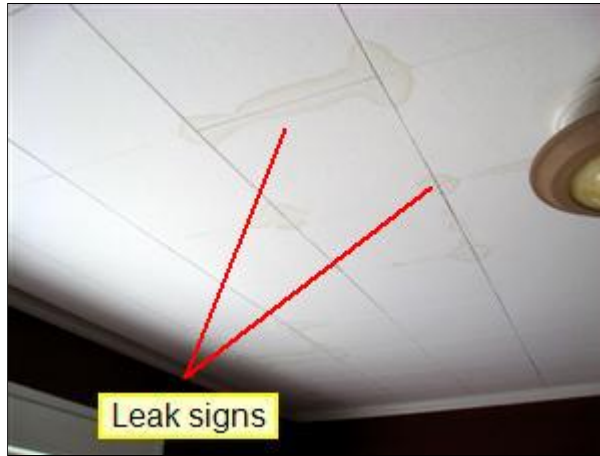
3.0 Picture 2

(2) The Ceiling Tile on the ceiling reveals a water stain indicating a leak did or still exists at the Bedroom. Due to recent dry weather, I am unable to determine if the leak still exists. A qualified contractor should inspect and repair as needed.

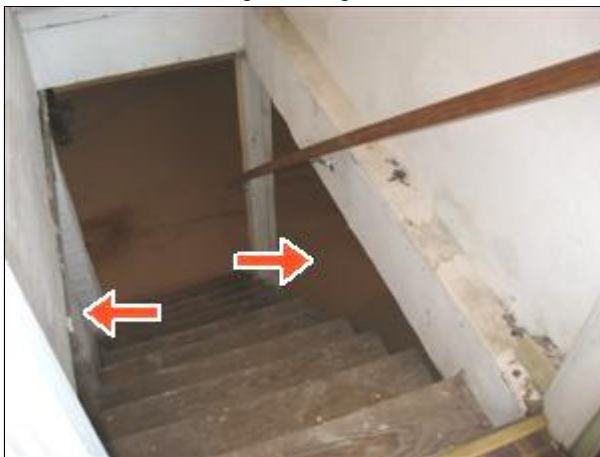
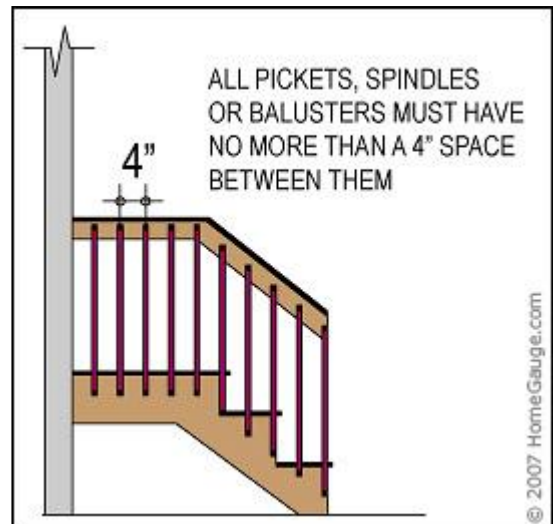
The hand/guard rail for the stairs to basement are missing balusters (on both sides). A fall or injury could occur if not corrected. A qualified contractor should repair or replace as needed.

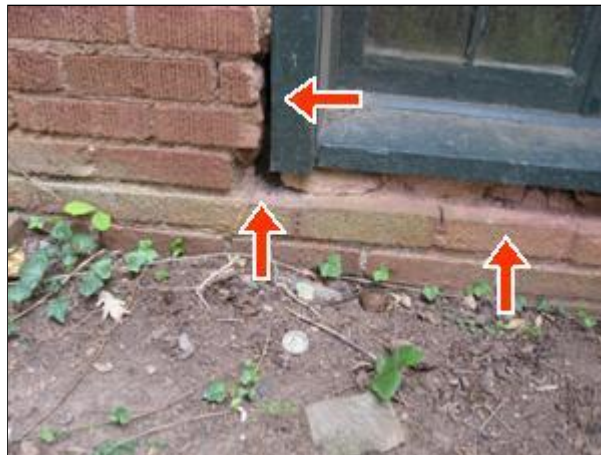
4.0 Picture 1

(1) Brick Foundation wall at the basement entry has missing mortar around windows . Repairs are needed. A skilled masonry contractor should perform the repairs.

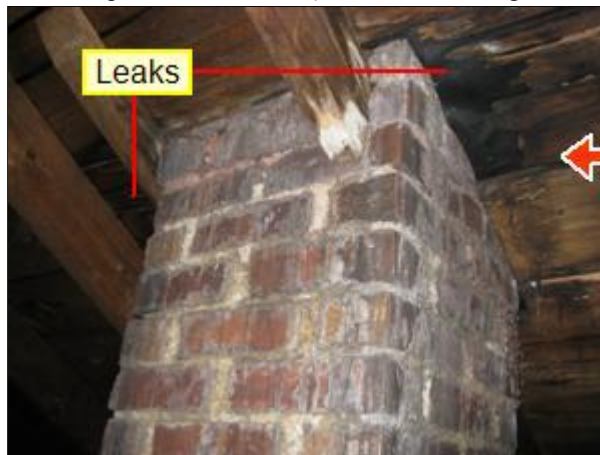
4.5 Picture 1

The common board roofing indicates roof leaks or has leaked around the chimneys. Leaking roofs should be repaired to prevent damage. I recommend a qualified contractor perform the work. (See Roof Coverings comments)

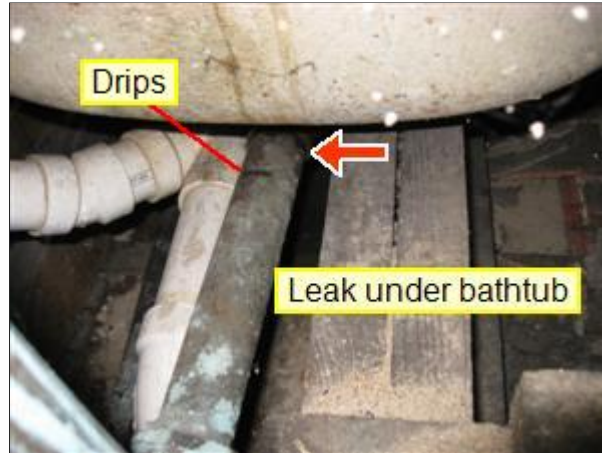
5.0 Picture 2 Upstairs bath

(2) The stop-valve does not work properly at the Hall Bath sink. Repairs are needed. The tub drain drains slowly at main bath. There is a leak under bathtub that can be seen from removing access panel on wall. Repairs are needed. A qualified licensed plumber should repair or correct as needed.

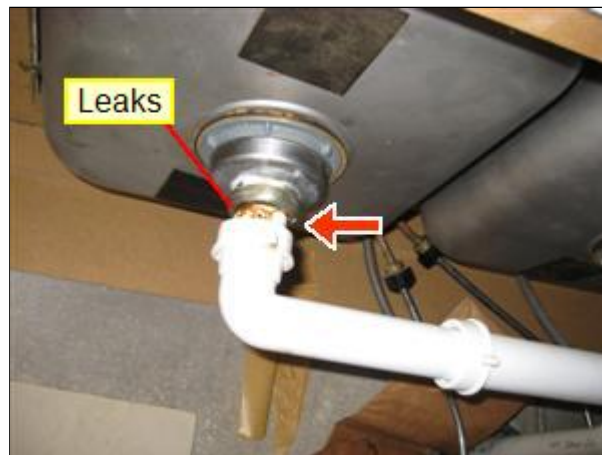
5.0 Picture 3

(3) The basket strainer is leaking at left side and at right side at the Kitchen sink. Repairs are needed. A qualified licensed plumber should repair or correct as needed.

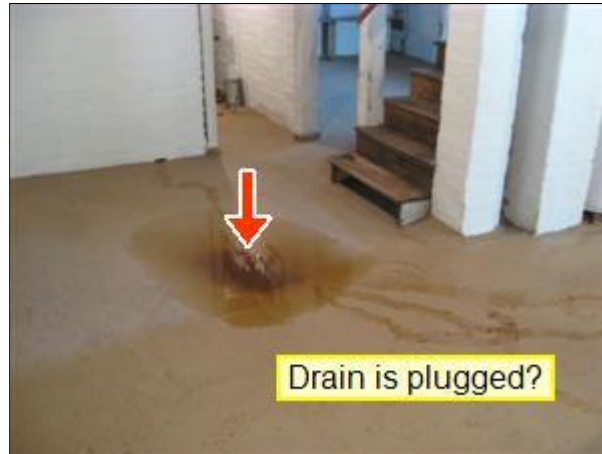
5.0 Picture 4 basement floor drain

(4) The floor drain has a plug as if to keep something from coming in? After the inspection, the owner of the adjacent property volunteered information that the city sewer occasionally will back up and come into basement. This may be the reason for the plug? I am unable to determine if plug will prevent this from occurring. FYI

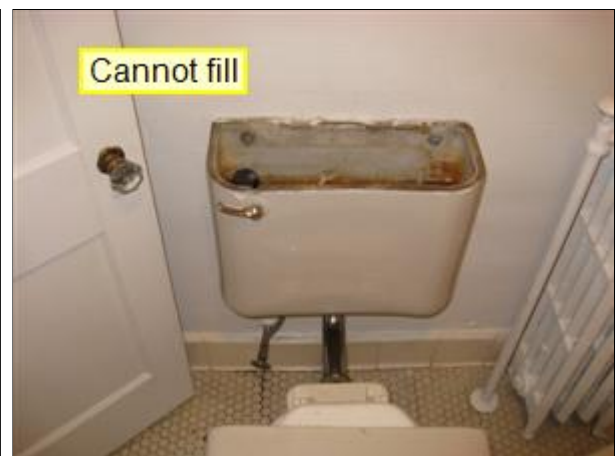
Toilet will not fill with water likely due to clogged piping. I could not inspect the toilet fixture for leaks.

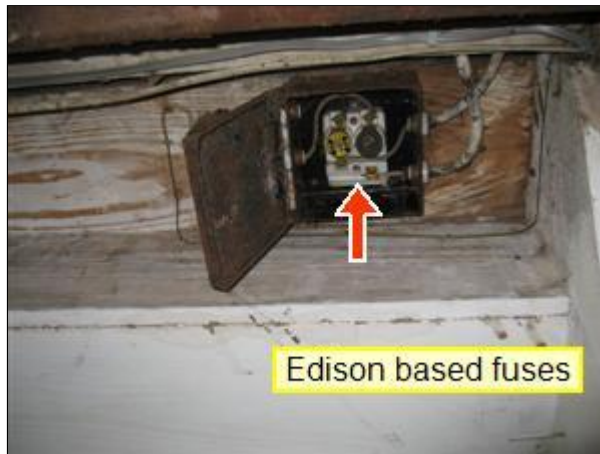
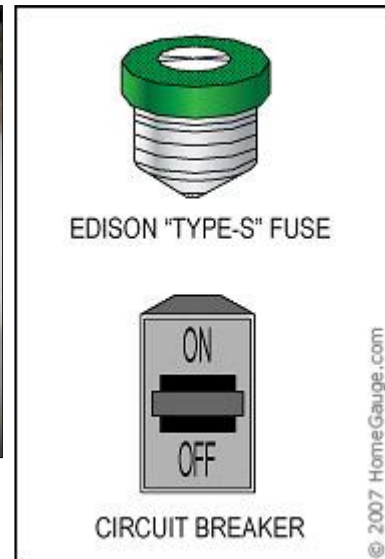
Problem(s) discovered with Branch Circuits such as doubled wiring at fuse(s), doubled wiring at circuit(s), and edison base fuse(s) under stairs, and any other problems that an electrician may discover while performing repairs need correcting. I recommend a licensed electrician inspect further and correct as needed.

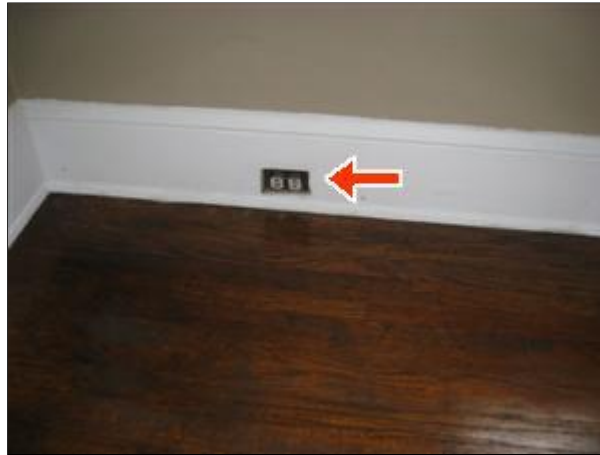
6.3 Picture 1 various rooms

(1) "Two-prong" outlets are missing cover-plates in the dining room and in the living room. This is a safety issue that needs to be corrected. I recommend repair as needed.

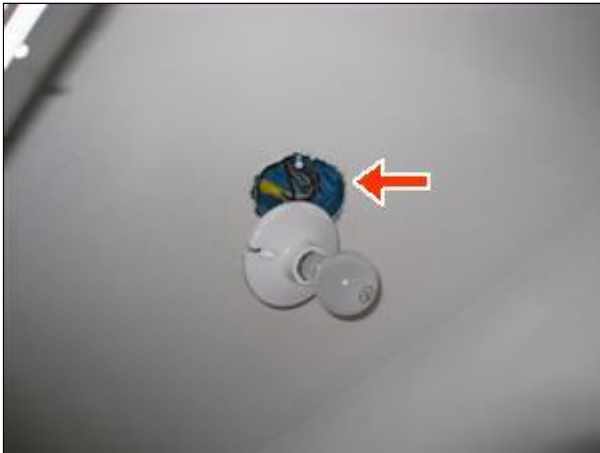
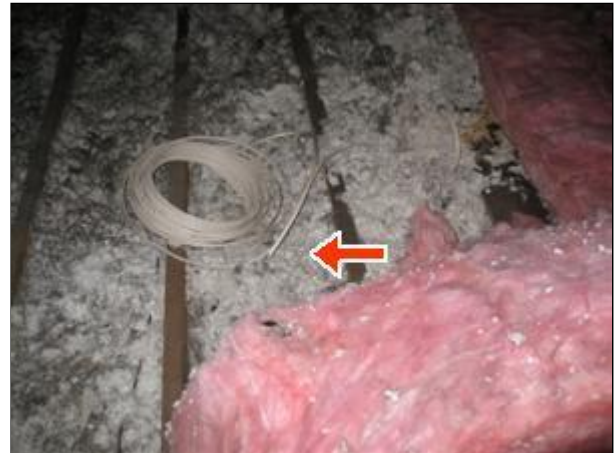
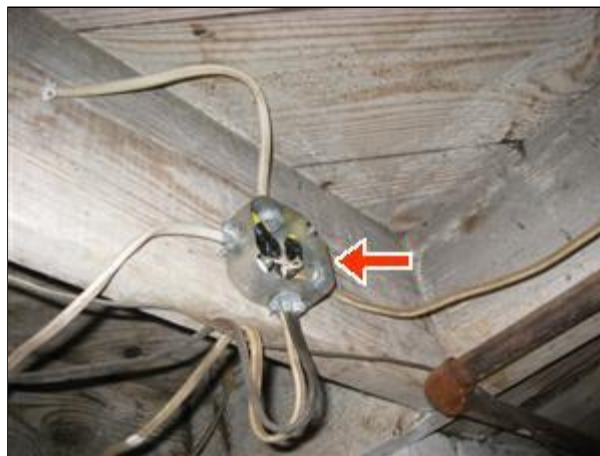
(2) Loose light fixture needs securing in closet. Loose or unfinished wiring in attic should be corrected to remain safe (Picture 2) .One splice box needs a cover-plate in the basement. I recommend repair as needed (Picture 4) .

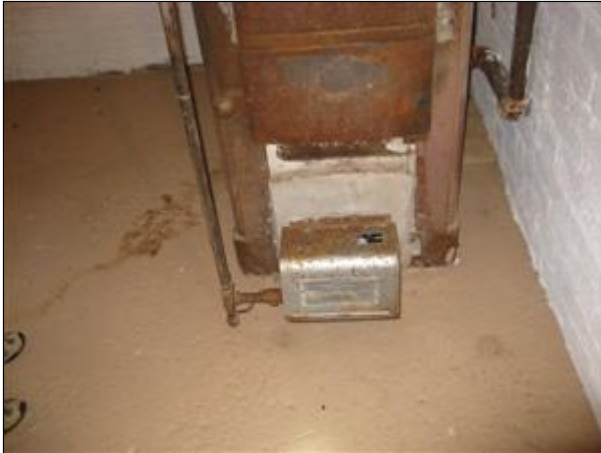
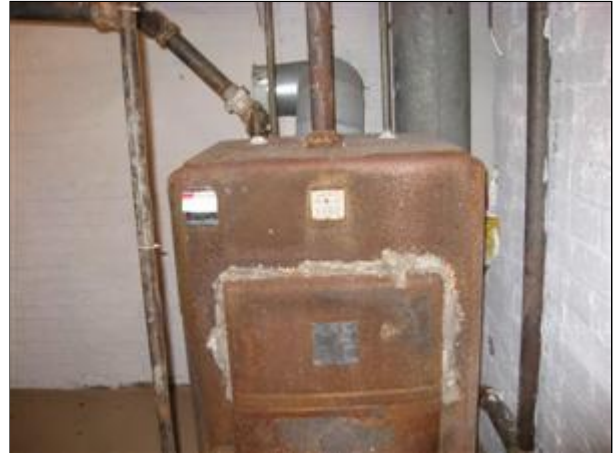
The gas-fired boiler did not function or is non-operational. A repair or replacement is needed. I recommend further inspection by a licensed HVAC contractor.
